Final Removal Action Report

Mansfield Trail Dump Site
Stanhope-Sparta Rd
Byram Township, Sussex County, New Jersey

Removal Support Team 2
Weston Solutions, Inc.
Northeast Division
Edison, New Jersey

January 2013

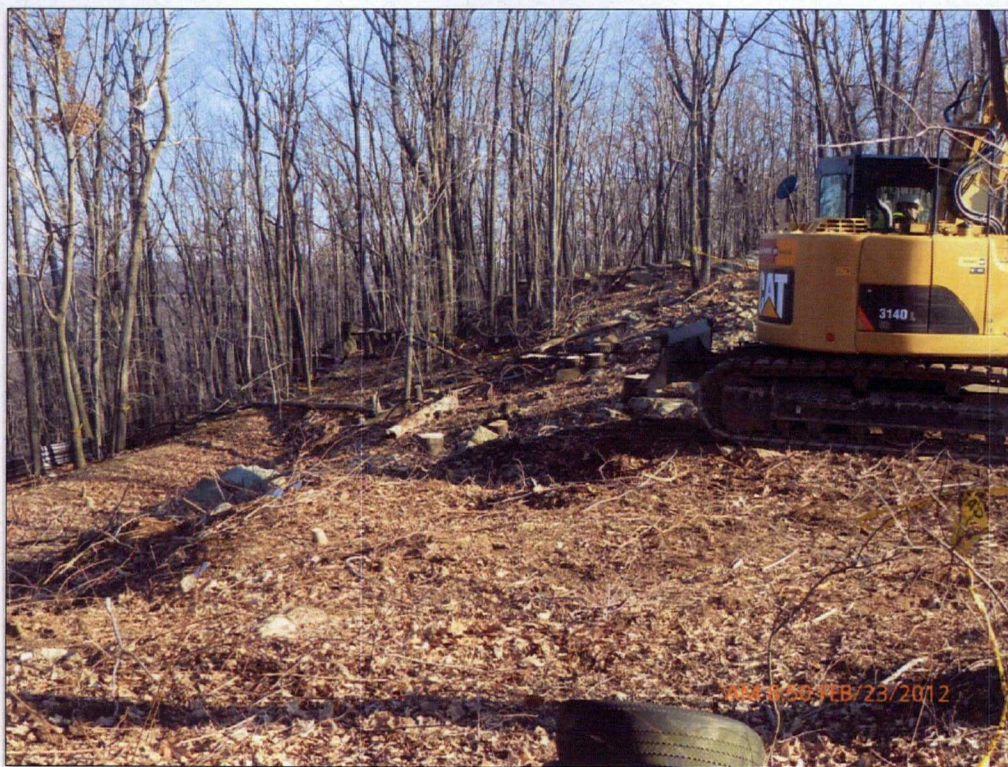
Photograph 1: A view of Dump Area A, taken on 2/23/12 at 0850 hrs.

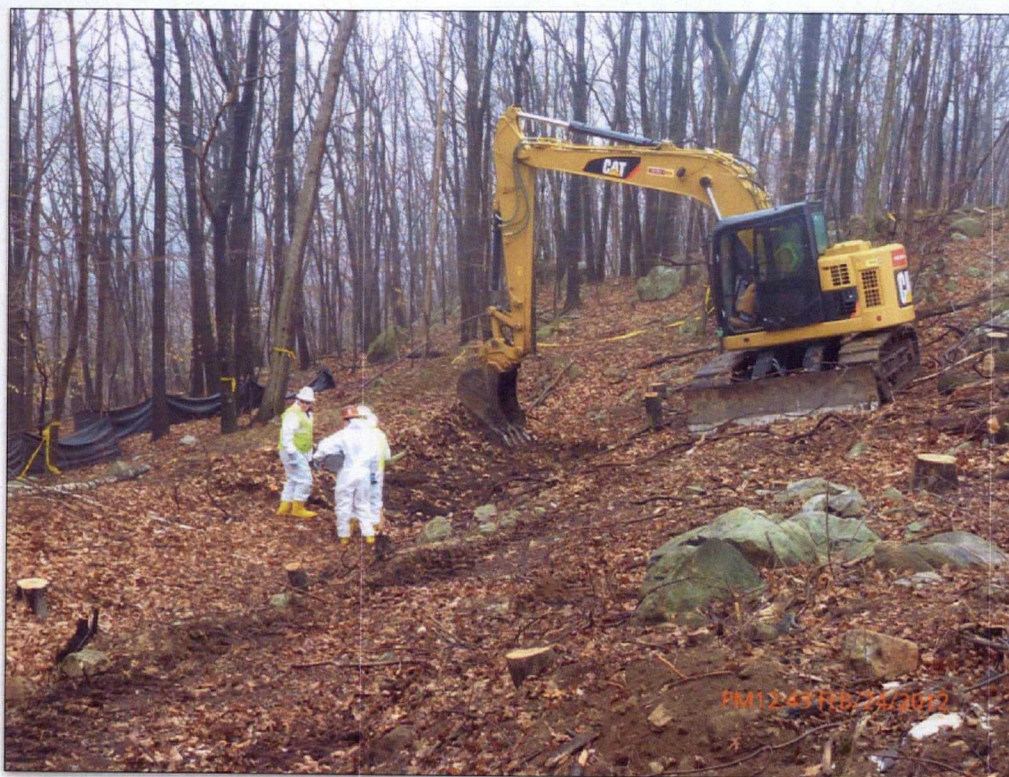
Photograph 2: A view of Dump Area A test pit sampling, taken on 2/24/12 at 1243 hrs.

Dump Area A: On February 24, 2012, ERRS collected waste characterization samples. A total of four five-point composite samples were collected from the Lower Trench and three five-point composite samples were collected from the Upper Trench. On March 6, 2012, as directed by the EPA On-Scene Coordinator (OSC), ERRS flagged the Upper and Lower Trenches to designate the areas with hazardous and non-hazardous material based on the analytical results from the samples collected. All sample points were flagged and Global Positioning System (GPS) points taken.

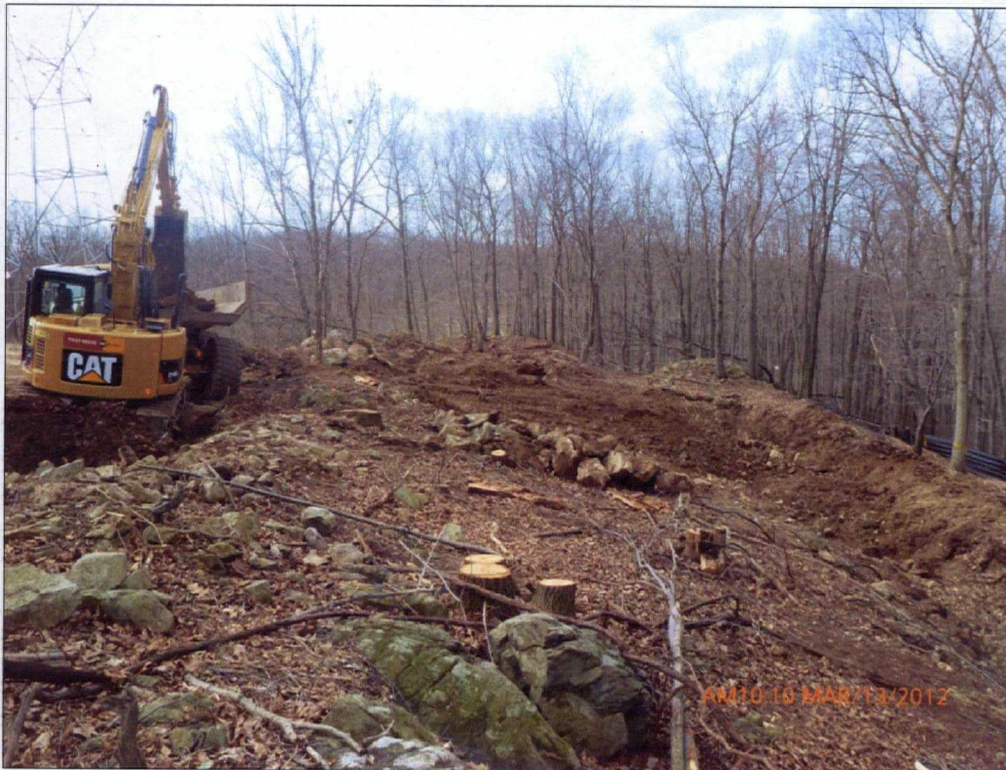
Photograph 4: A general view of Dump Area A excavation activities between Upper and Lower Trench facing South, taken on 3/13/12 at 1010 hrs.

Dump Area A. In the afternoon, ERRS removed 110 yards of non-hazardous material from the Upper Trench of Dump Area A. Crew prepared for sump pump installation, cleanup work area and secured silt fence around staging area in Dump Area E. RST 2 conducted oversight and documented site activities. RST 2 personnel conducted soil sampling in Dump Area C. A total of 20 soil samples were collected and hand-delivered to EPA DESA laboratory for VOC analysis. RST 2 collected three air samples from Dump Area A in the morning, two air samples from Dump Area A in the afternoon, and a field blank. Refer to Attachment C for Perimeter/Excavation Air Sampling Report.

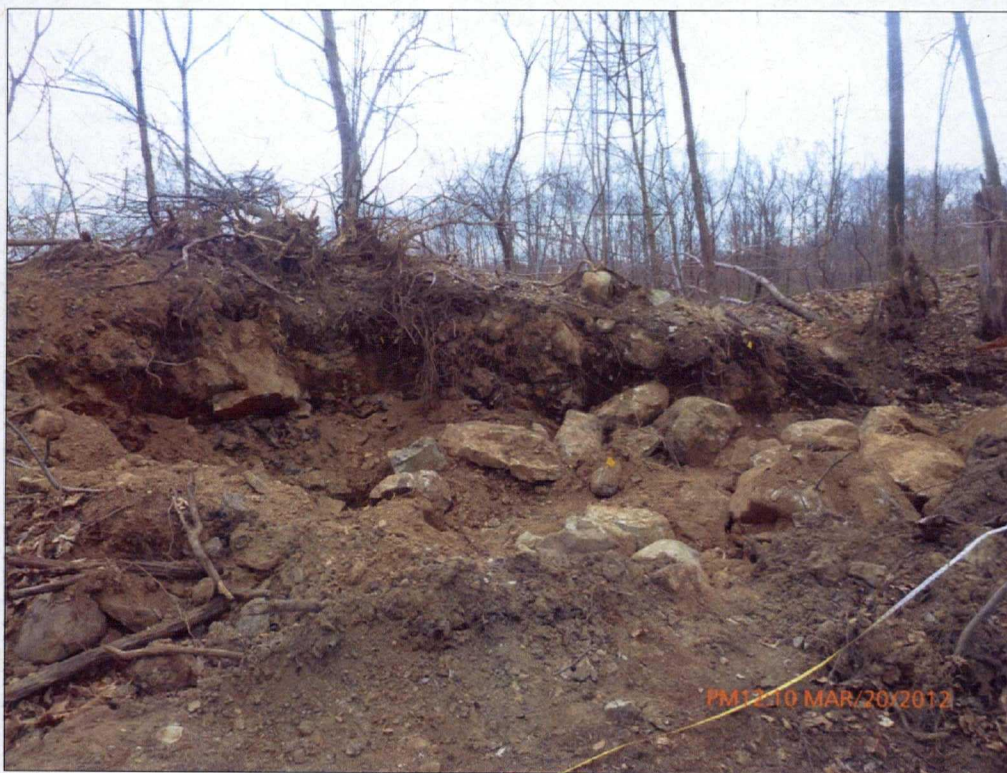
Photograph 8: A general view of Dump Area A excavation activities in Upper Trench facing East, taken on 3/20/12 at 1210 hrs.

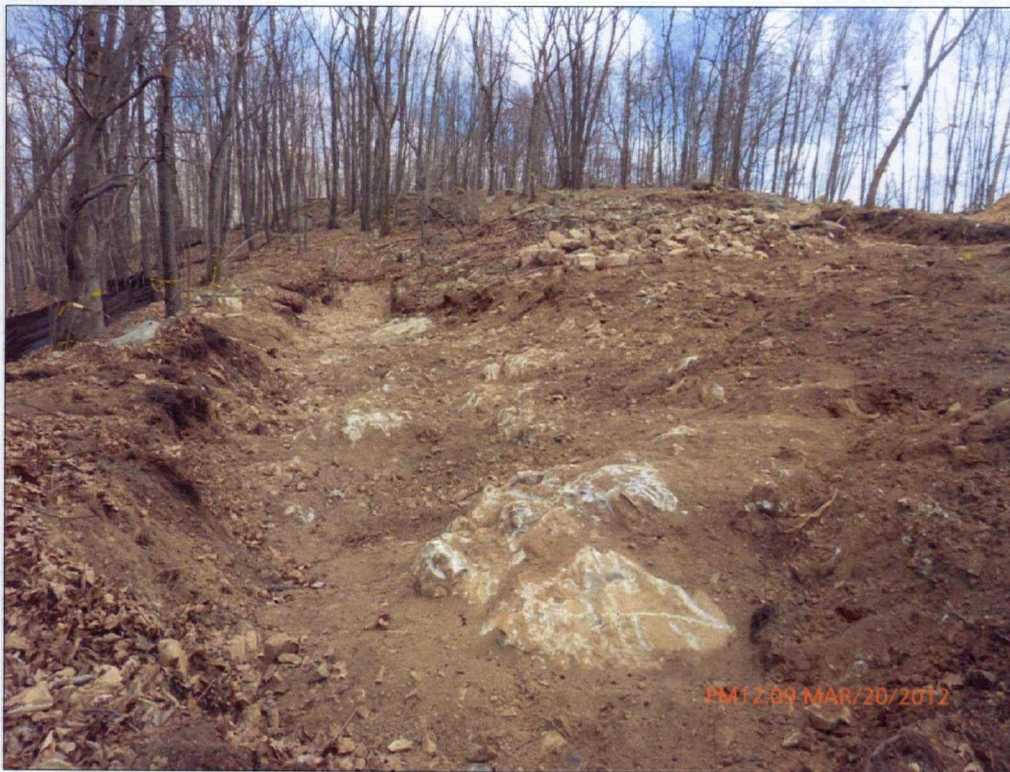
Photograph 10: A North facing view Dump Area A Lower Trench, taken on 3/20/12 at 1209 hrs.

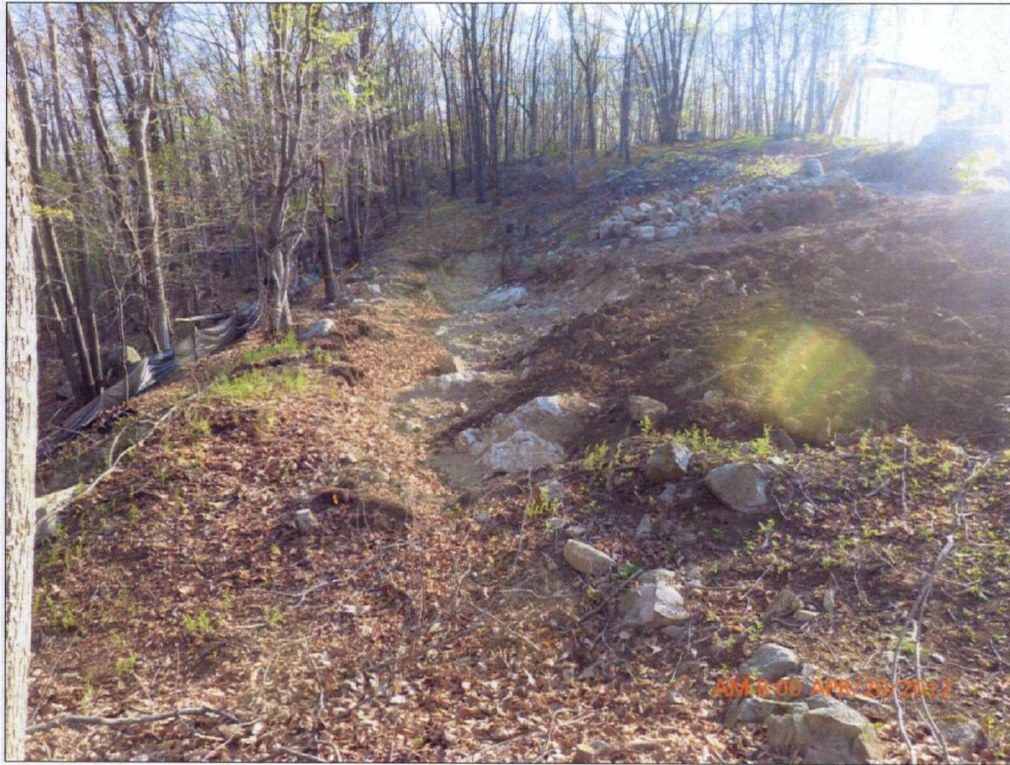
Photograph 11: A North facing view of Dump Area A Lower Trench, taken on 4/20/12 at 0800 hrs.

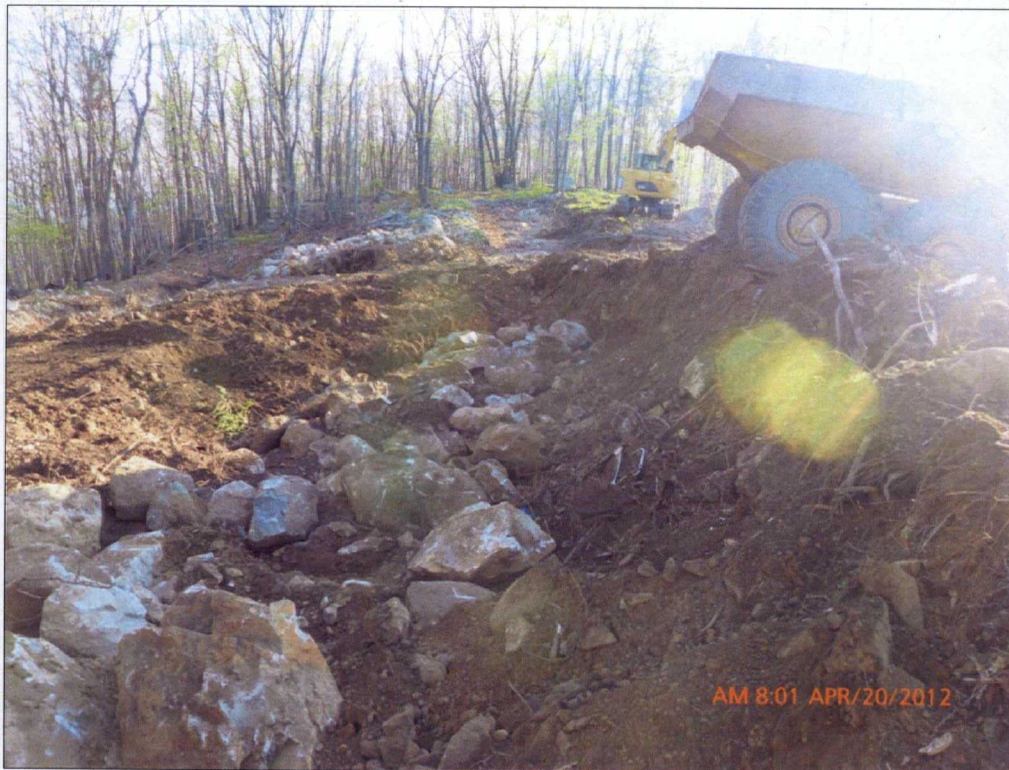
Photograph 12: A North facing view of Dump Area A Lower Trench, taken on 4/20/12 at 1209 hrs.

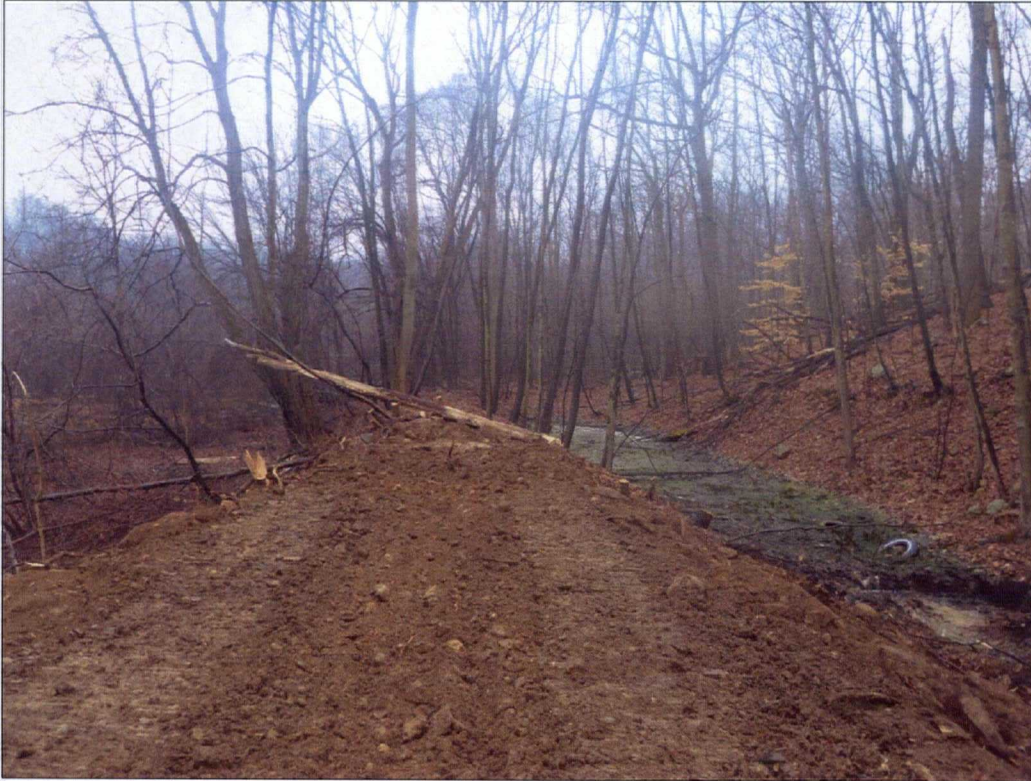
Photograph 1: A view of Dump Area B following the construction of an earthen berm road, taken on 2/15/12 at 1236 hrs.

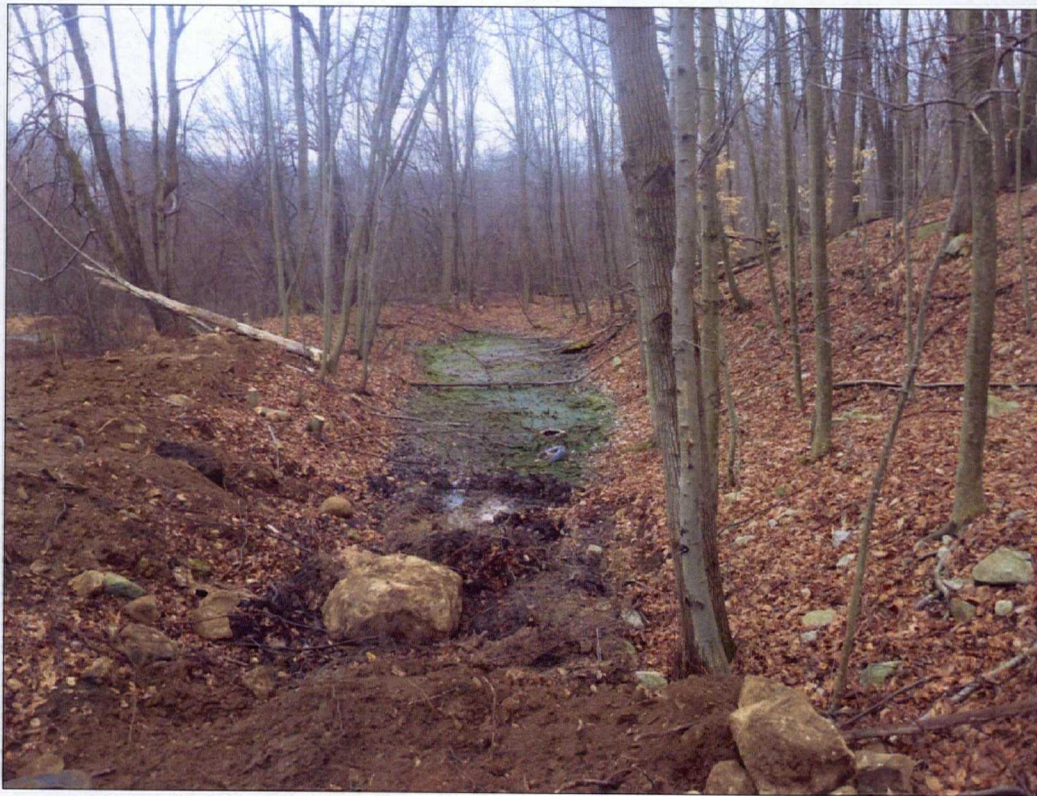
Photograph 2: A view of Dump Area B prior to removal activities, taken on 2/16/12 at 1024 hrs.

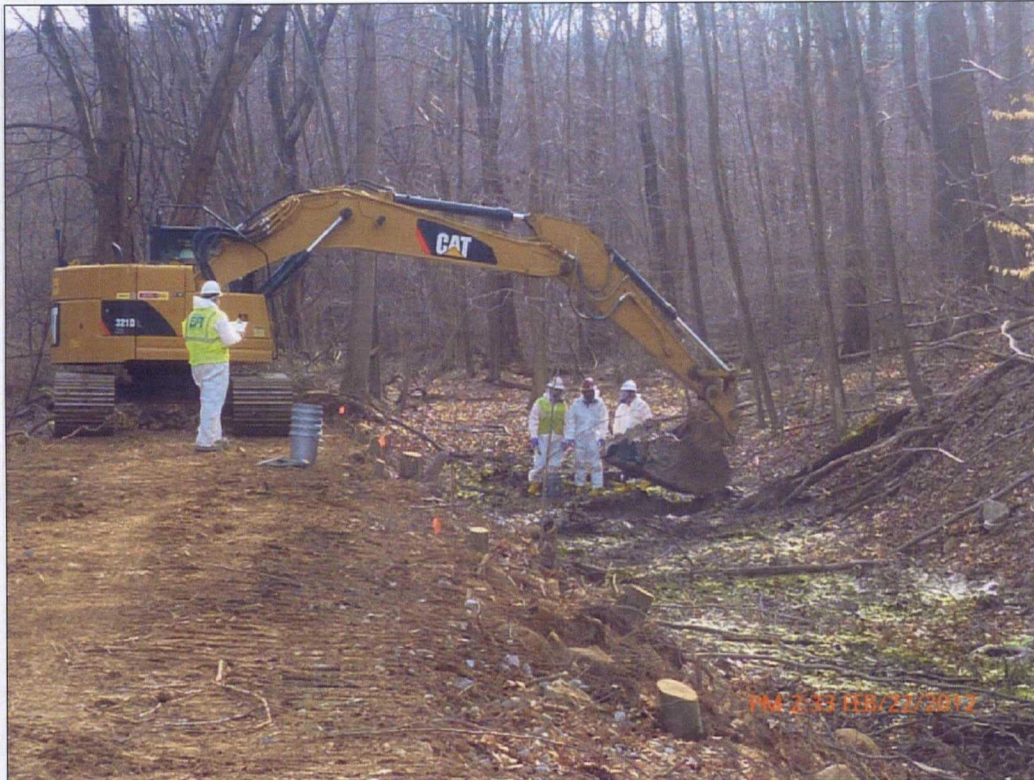
Photograph 3: A view of Dump Area B, ERRS collecting soil samples, taken on 2/22/12 at 1433 hrs.

Dump Area B: ERRS sampled Dump Area B on February 22, 2012. A total of three five-point composite samples were collected from the single trench in this area. The ERRS contractor collected the samples and RST 2 provided oversight. On March 6, 2012, as directed by the OSC, ERRS flagged the hazardous and non-hazardous material areas in Dump Area B based on the analytical results from the samples collected. All sample points were flagged and GPS points taken.

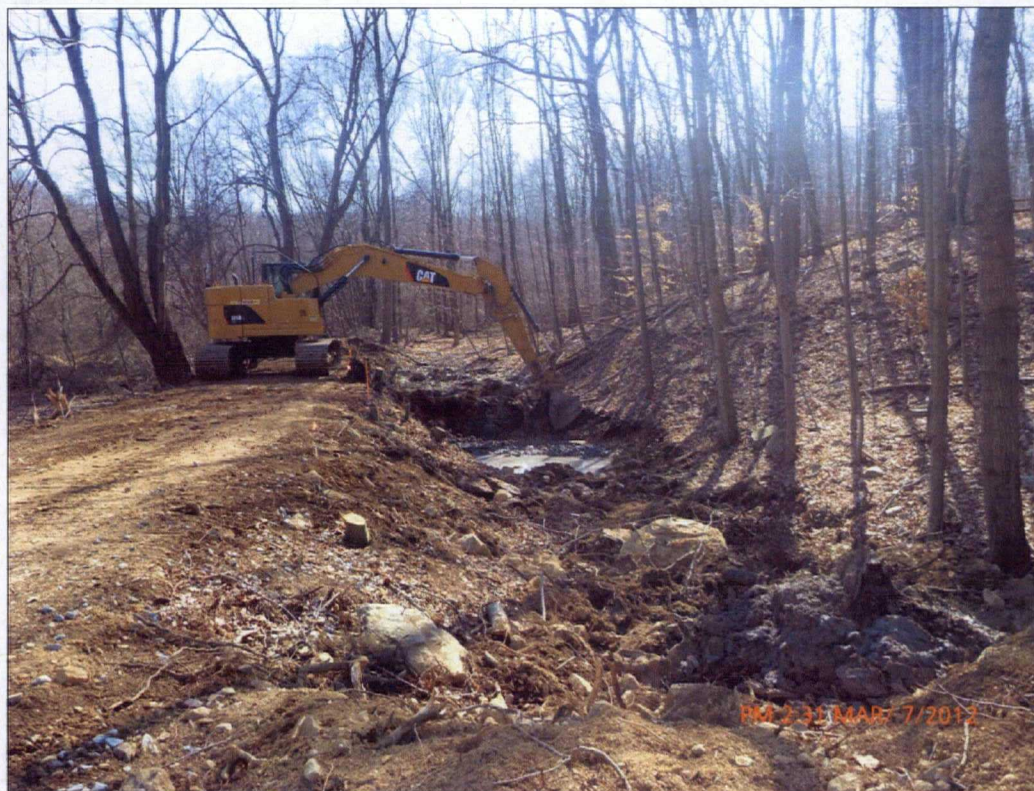
Photograph 4: A view of Dump Area B excavation activities for a dewatering retention basin facing South, taken on 3/07/12 at 1431 hrs.

Dump Area B: On March 7, 2012, a total of 80 yards of hazardous material was removed from Dump Area B and stockpiled in the north section of Dump Area E. After the removal of the hazardous material from the trench in Dump Area B, an earthen berm was created between the excavated area and the area containing the non-hazardous material. Between March 14 and 15, 2012, a sump was installed in the trench to de-water the remaining material. From March 21 to 23, 2012, approximately 100 yards of non-hazardous waste was removed from the trench and stockpiled in the south section of Dump Area E. On March 23, 2012, ERRS removed the earthen berm and completed removal from this area. All excavation was completed to bedrock.

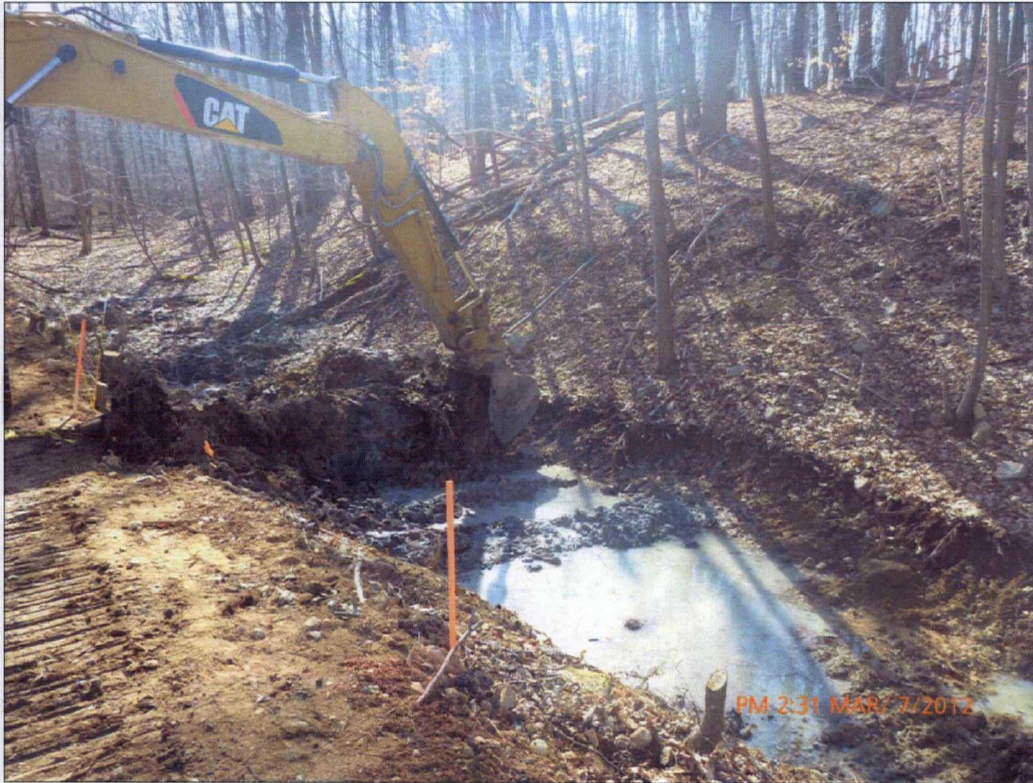
Photograph 5: A view of Dump Area B excavation activities for a dewatering retention basin facing South, taken on 3/07/12 at 1431 hrs.

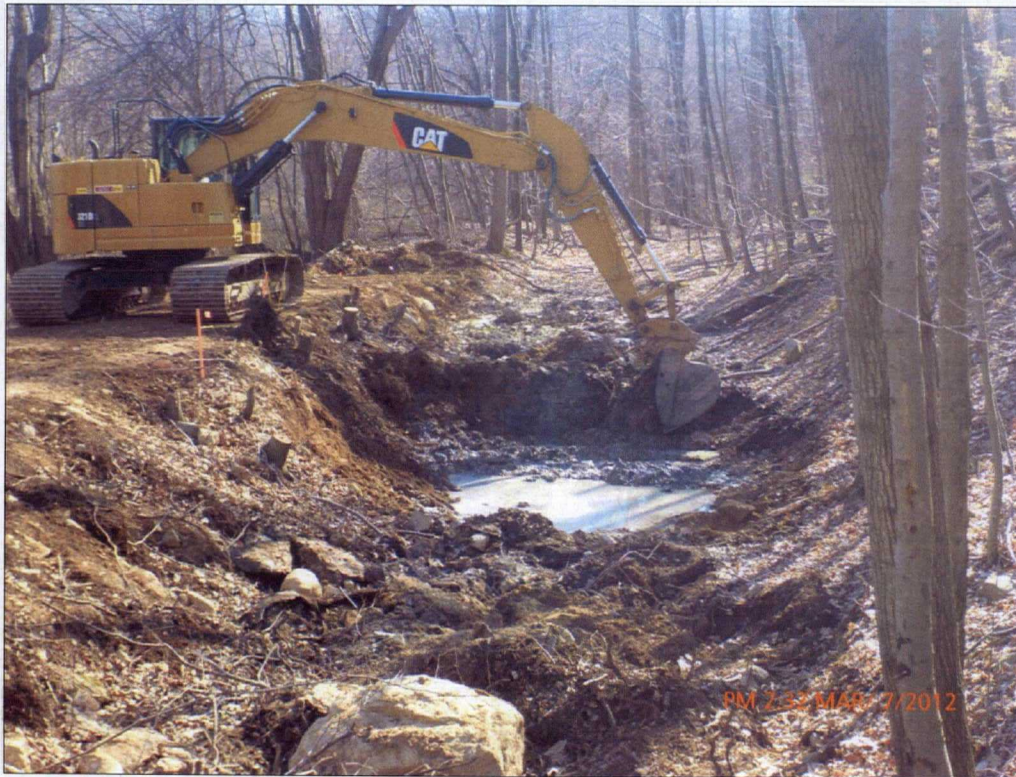
Photograph 6: A view of Dump Area B excavation activities for a dewatering retention basin facing South, taken on 3/07/12 at 1432 hrs.

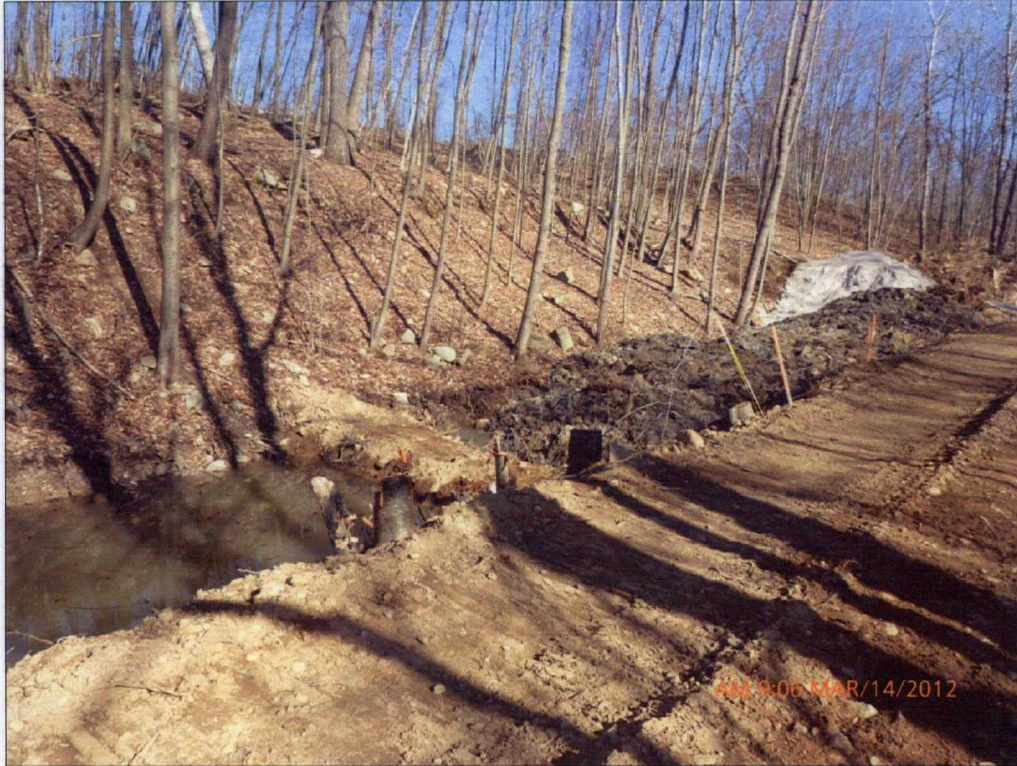
Photograph 7: A view of Dump Area B facing North West, taken on 3/14/12 at 0906 hrs.

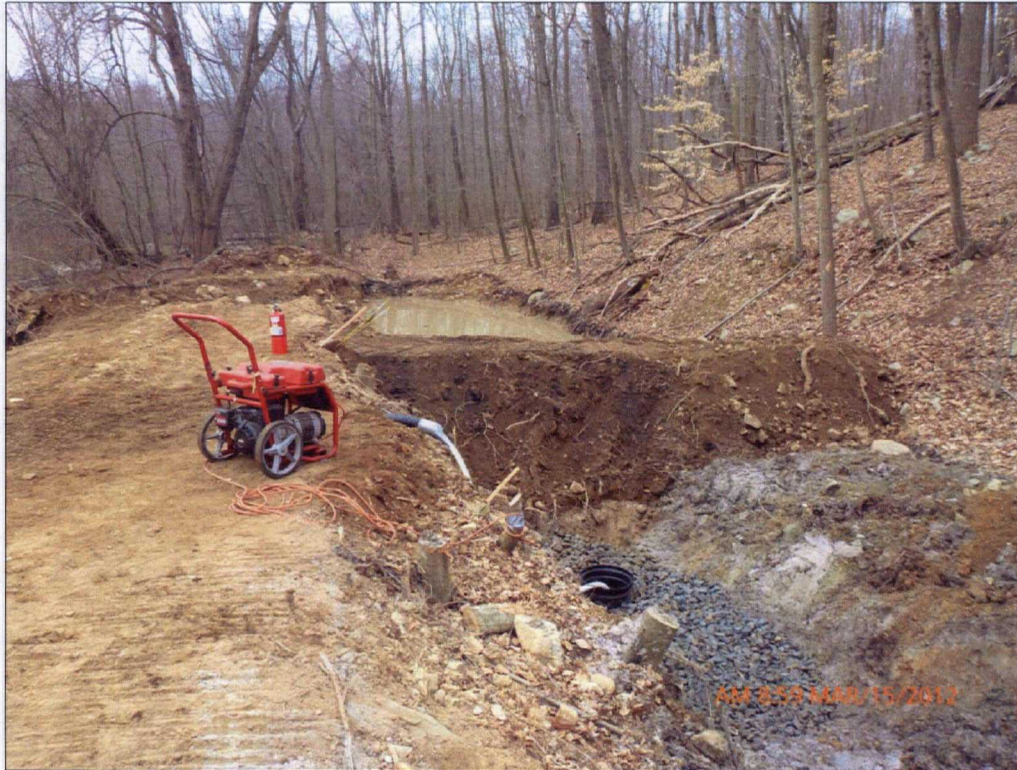
Photograph 8: A view of Dump Area B, sump pumping activities facing South, taken on 3/15/12 at 0859 hrs.

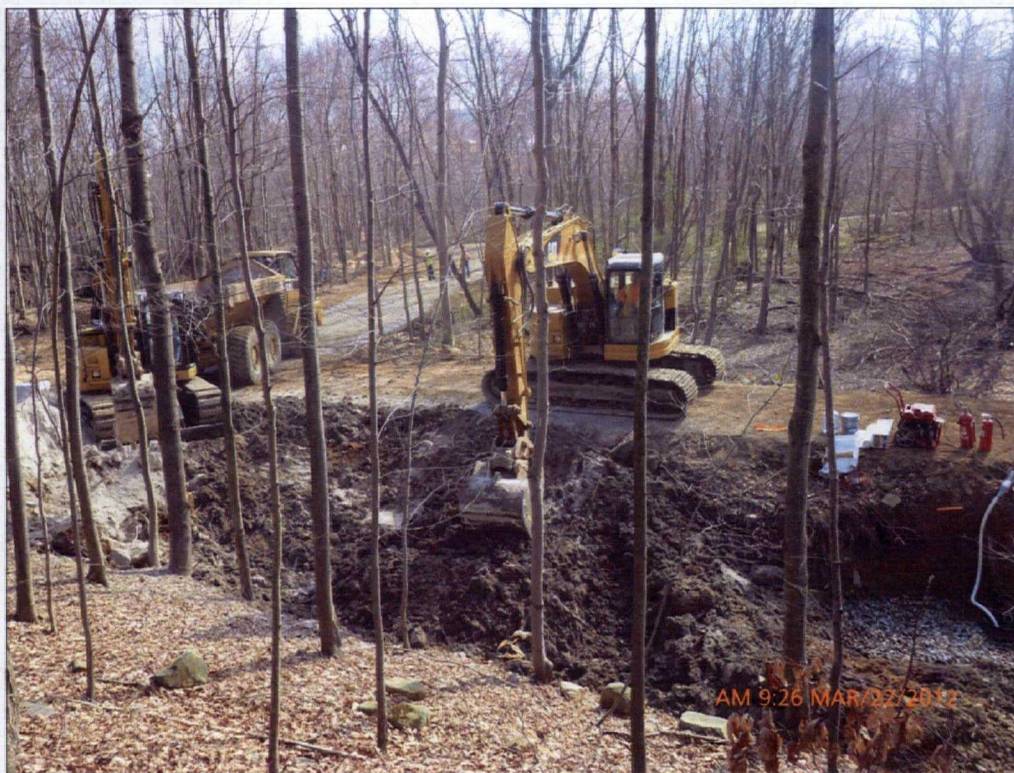
Photograph 9: A view of Dump Area B excavation of non –hazardous material with the addition of kiln dust for dewatering, taken on 3/22/12 at 0926 hrs.

Thursday, March 22, 2012: ERRS excavated non-hazardous material from the trench in Dump Area B, where six truck loads were transported to staging area. Kiln dust was mixed with the material to bind the liquids. A total of nine trucks transported non-hazardous material off site from 0630 hrs to 0900 hrs.

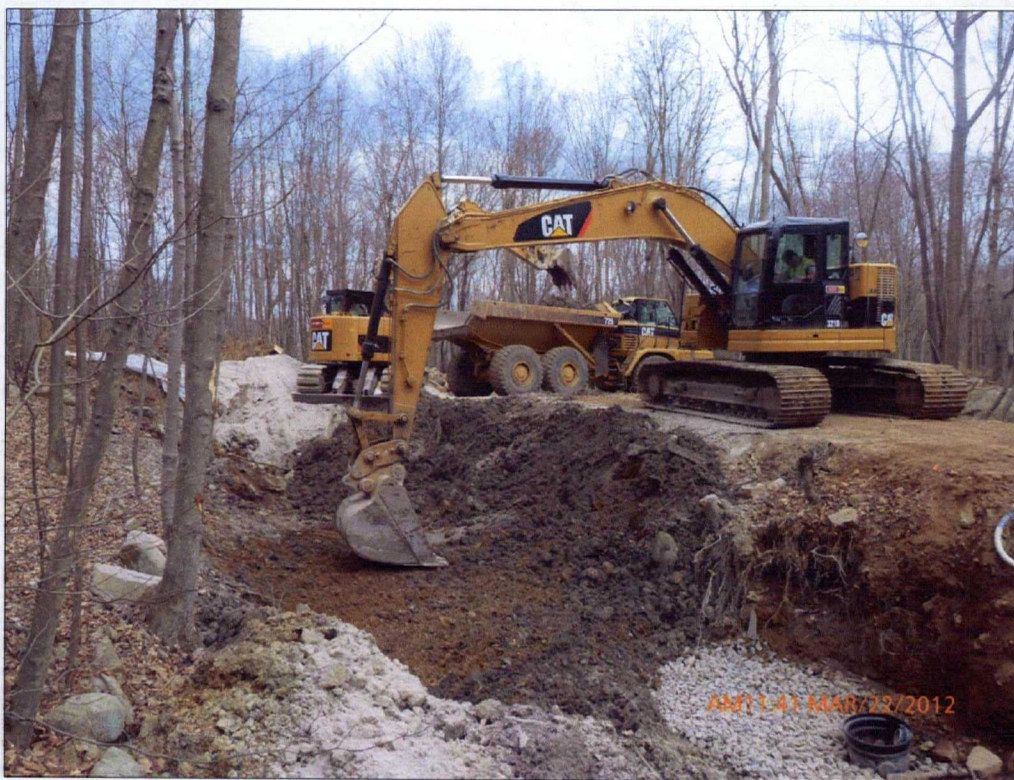
Photograph 10: A view of Dump Area B excavation activities, taken on 3/22/12 at 1143 hrs.

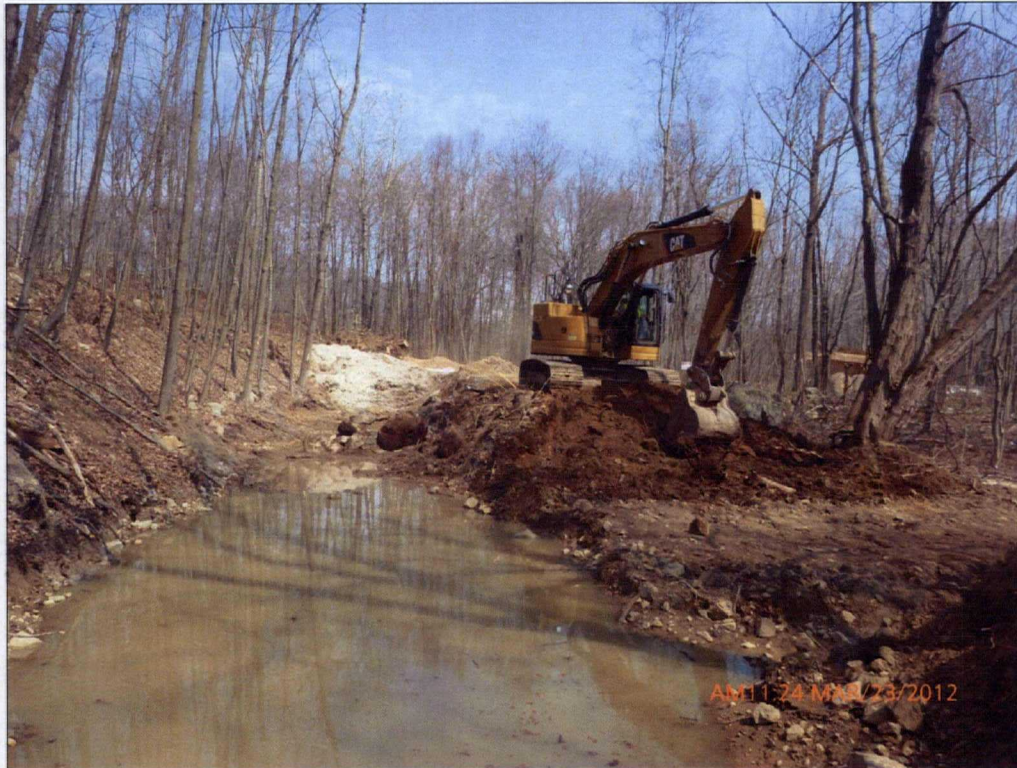
Photograph 11: A view of Dump Area B removal of the road berm, taken on 3/23/12 at 1124 hrs.

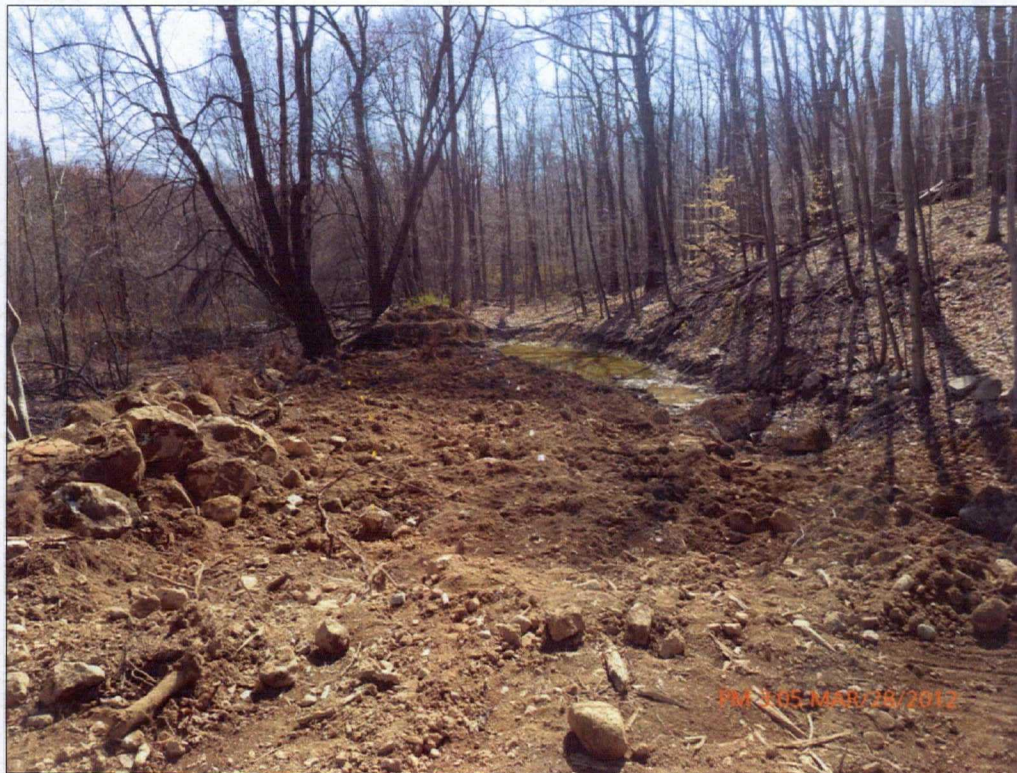
Photograph 12: A general view of Dump Area B facing South, taken on 3/28/12 at 1305 hrs following post excavation soil sampling event.

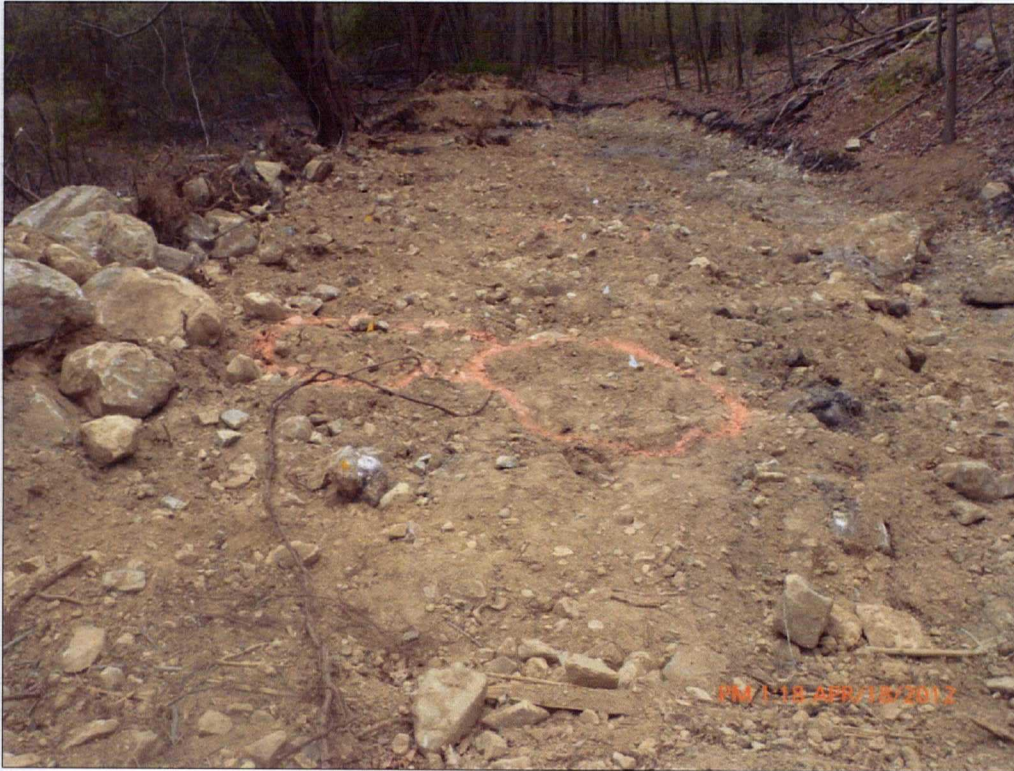
Photograph 13: A close view of Area B marked sample points in to be removed, taken on 4/18/12 at 1319 hrs.

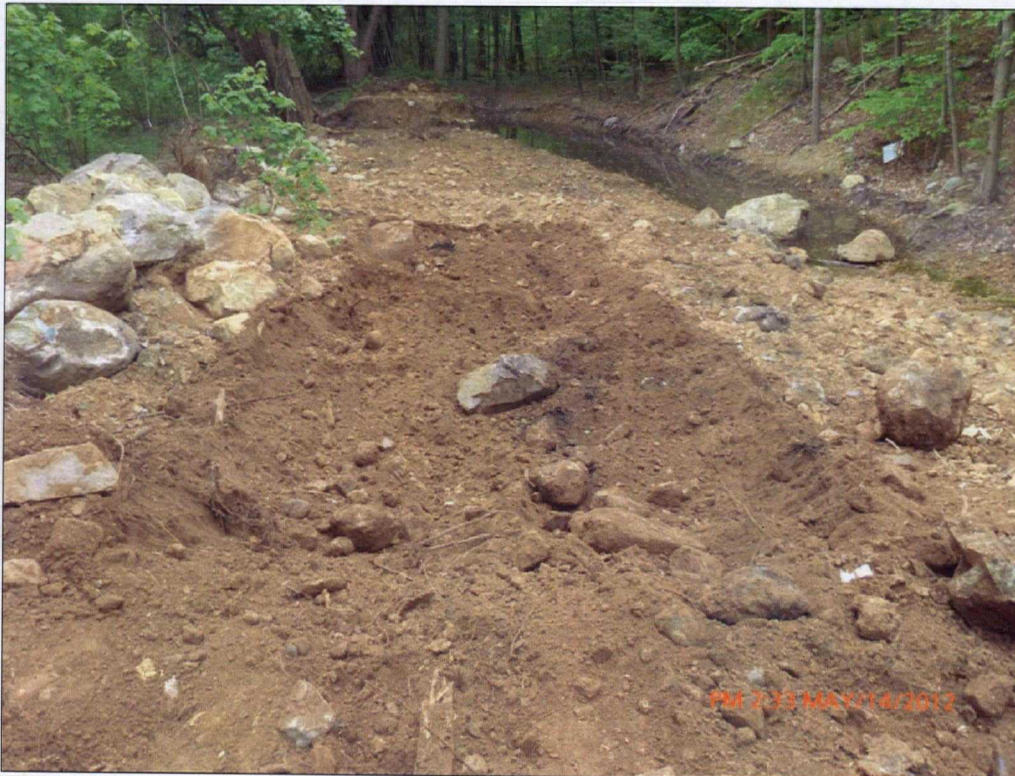
Photograph 15: A view of the excavation in Dump Area B after sample locations that were above action levels were removed, taken on 5/14/12 at 1433 hrs.

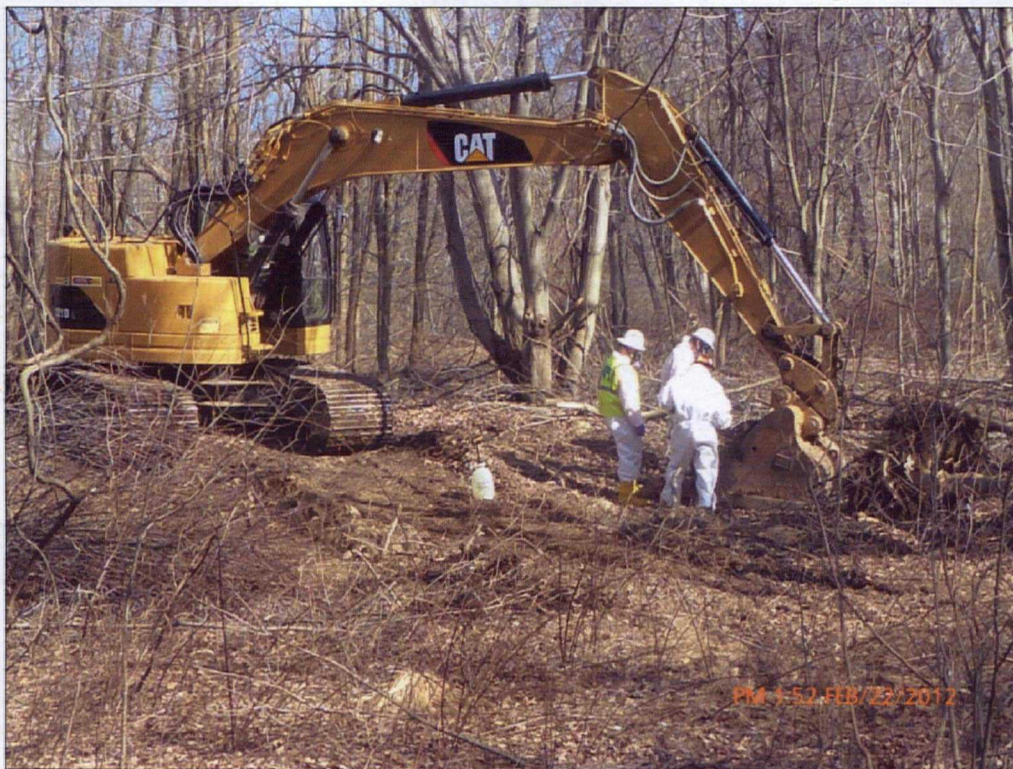
Photograph 1: A view of Dump Area C, ERRS collecting soil samples, taken on 2/22/12 at 1353 hrs.

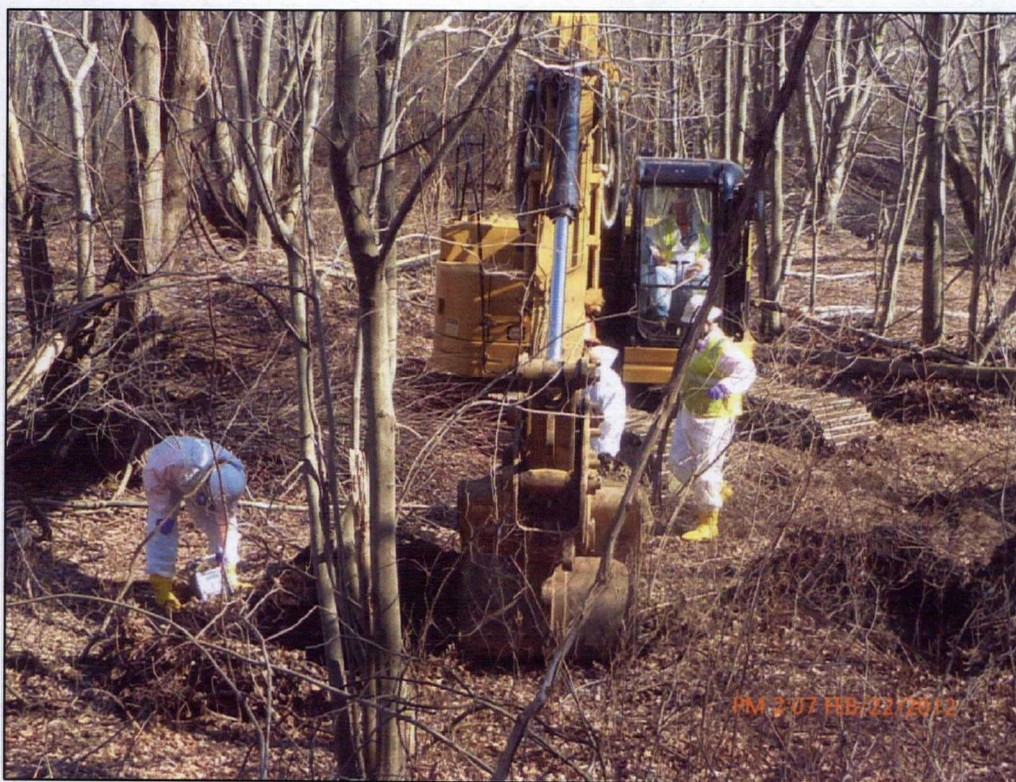
Photograph 2: A view of Dump Area C, ERRS collecting soil samples, taken on 2/22/12 at 1407 hrs.

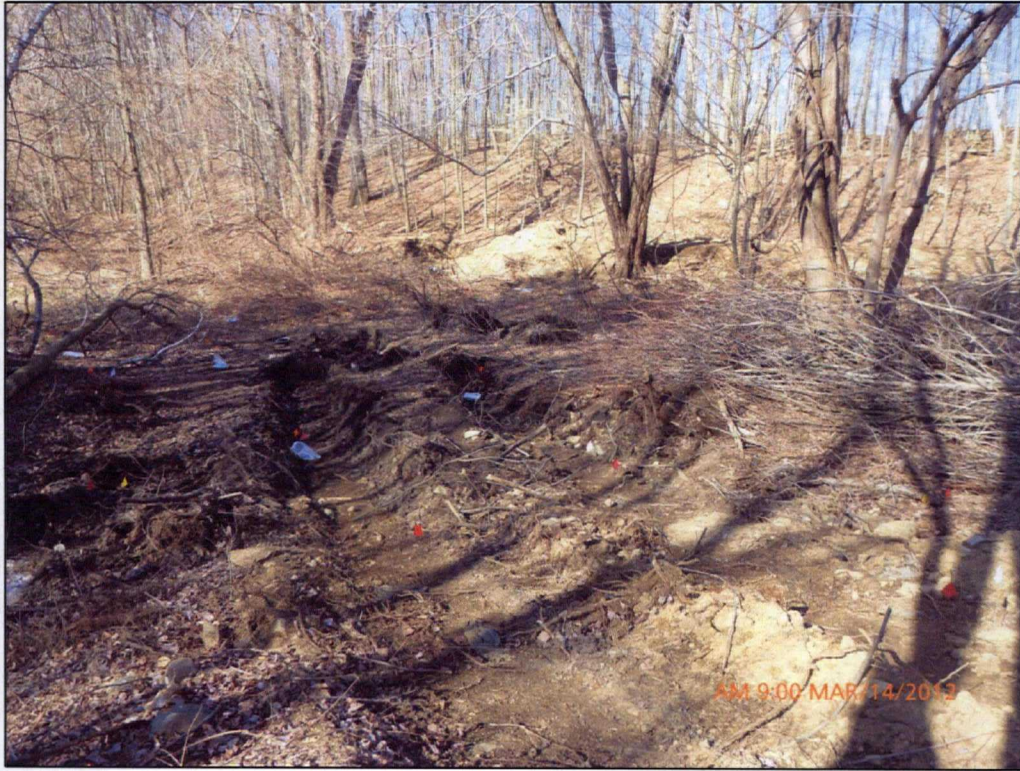
Photograph 3: A view of Dump Area C during RST 2 sampling event facing South, taken on 3/14/12 at 0900 hrs.

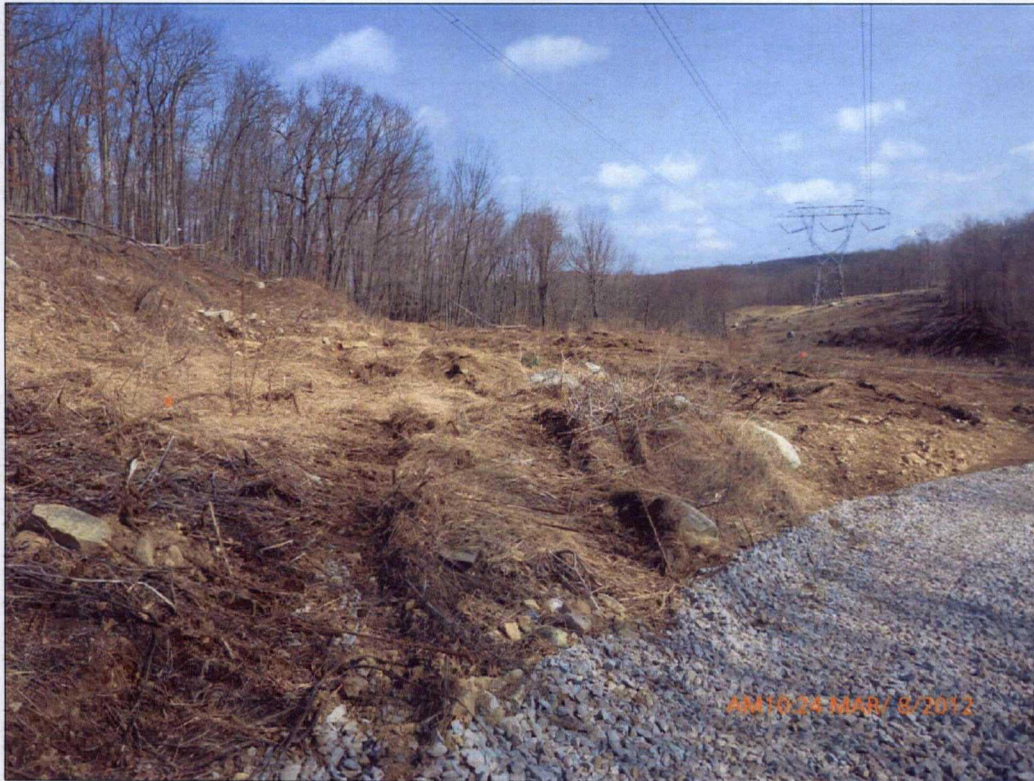
Photograph 1: A view of Dump Area D prior to removal activities, taken on 2/17/12 at 0915 hrs.

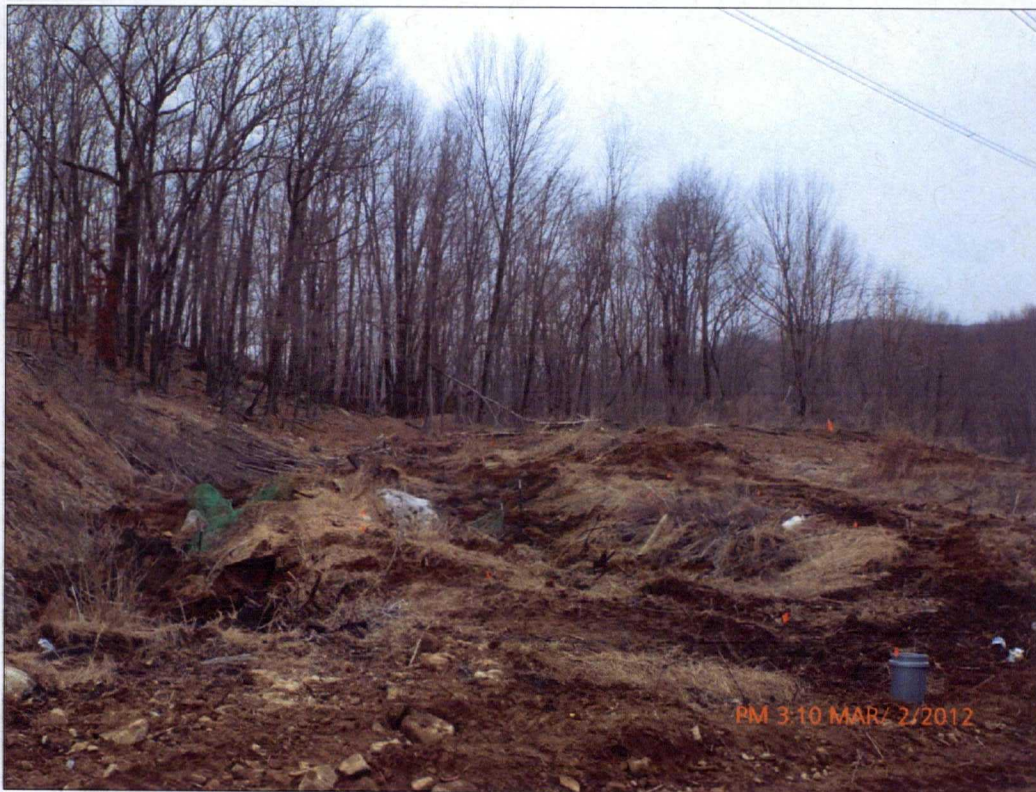
Photograph 2: A view of Dump Area D, test pit sampling, taken on 3/2/12 at 1510 hrs.

Dump Area D: ERRS sampled Dump Area D on March 2, 2012. A total of 20 five-point composite samples were collected from Trenches 1, 2, 3 and 4. The ERRS contractor excavated test pits and collected the samples and RST 2 provided oversight. Material in Trenches 1, 3 and 4 in Dump Area D contained non-hazardous material according to the analytical results. Trench 2 contained sulfide reactive material and was stockpiled and disposed in separate loads from the non-hazardous material. All sample points were flagged and GPS points taken.

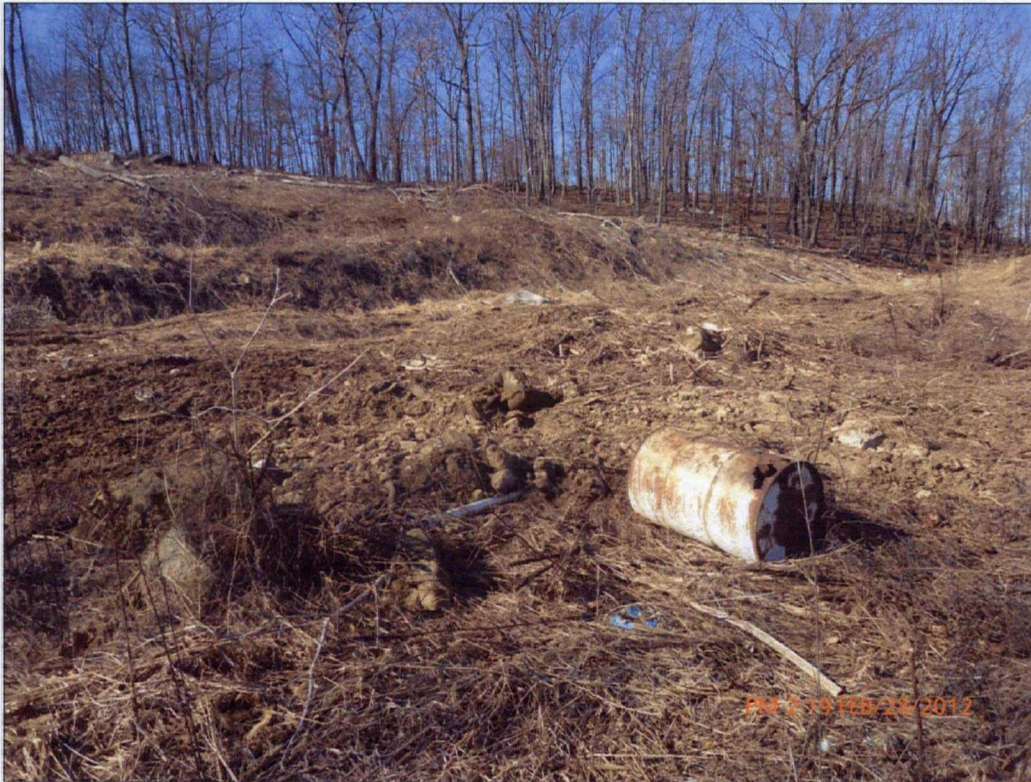
Photograph 3: An overview of Dump Area D facing Northwest prior to excavation activities, taken on 2/28/2012 at 1419 hrs.
